## GEOPHYSICS: AN ESSENTIAL TOOL IN GEOTECHNICAL AND ENVIRONMENTAL SITE INVESTIGATION

The role of geophysics as a tool for geotechnical and environmental engineering site investigation at Igarra, Akoko Edo Area of Edo State, Nigeria was studied using integrated geophysical method involving electromagnetic (Very Low Frequency, VLF) and electrical resistivity (dipole - dipole) methods. The study is aimed at providing a cost effective, fast, and accurate and a holistic information of the subsurface on which proposed structures would be built for future development. Three traverses of length 205m each were laid to establish the orientation and consistency of the subsurface geological structures (faults and fractures). The traverses were laid in South-North direction perpendicular to the orientation of the geological structure (faults and fractures). The VLF method identified the conductive zones along the profile which is indicative of geological structure. Positive peak points on the VLF profile indicate high conductive zones that coincide with low resistivity zones on the dipole-dipole pseudo-section. The results obtained from the two methods show consistency of result which is indi

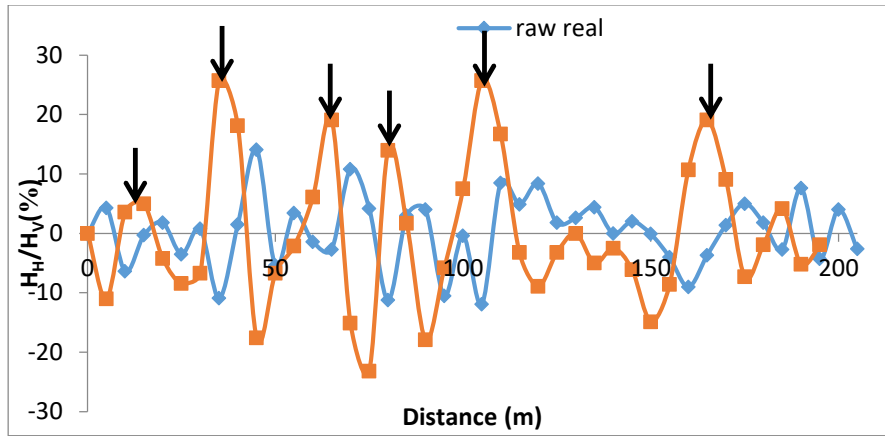
Figure 4a: (VLF) profile and pseudo-section for Traverse 1

Karous-Hjelt filtering  
Igarra Traverse 1<sup>st</sup>

**Very Low Frequency:** Figure 4a presents the VLF profile and pseudo-section for traverse 1. Stations distances of 15m, 35m, 65m, 80m, 105m, 165m, and 185m show high conductivity response of 5%, 25.7%, 19.1%, 14%, 25.7%, 19.1% and 4.2% respectively which indicates the presence of conductive body and suggestive of geological structure which could be fault or fracture.
